Manhole Inspection Summary

Manhole # S17WW_004MH

Location Address: **3301 DRUID PARK DR**

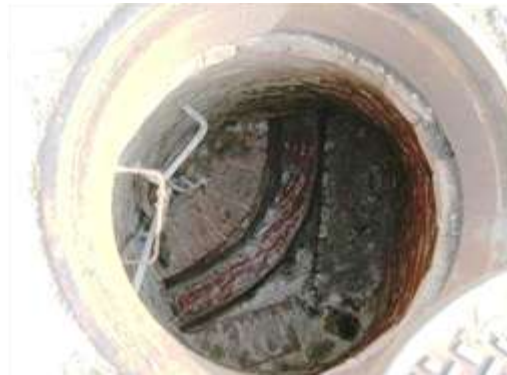
Top View

Evidence of surcharge - Bench debris.
Corroded steps.

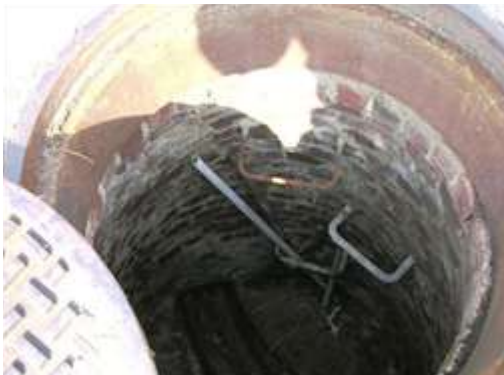
Defect

Frame leaks. Adjustment, Corbel, and
Barrel infiltration.

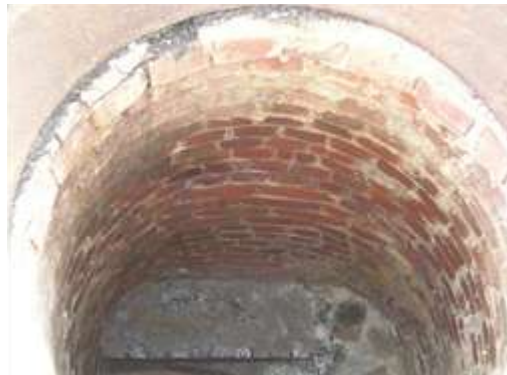
Defect

Frame leaks. Adjustment deterioration
and cracks. Adjustment, Corbel, and
Barrel infiltration.

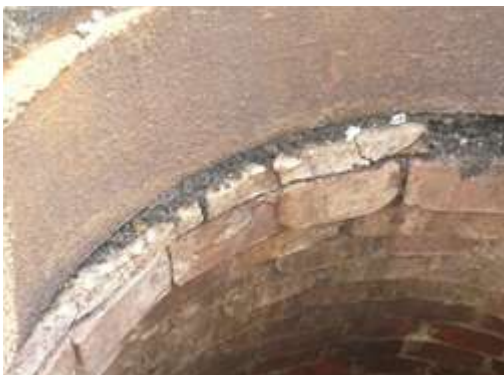
Defect

Frame leaks. Adjustment deterioration
and cracks. Adjustment and Corbel
infiltration.

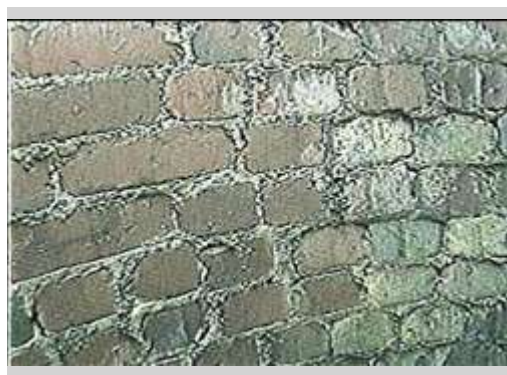
Defect

Barrel deterioration and infiltration.

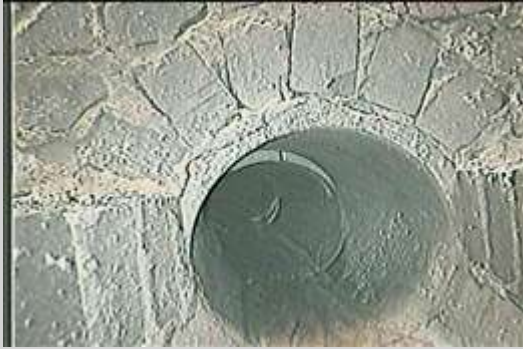
10 in. Circular Gravity Sewer Pipe Out @ 12 O'Clock

Comments **The O12 pipe picture shows Channel deterioration.**

Deposits: ☐ None ☐ Mud ☐ Sludge ☐ Debris ☒ **Grease**

Infiltration: **Evidence** Pipe Seal Cond: **Unknown**

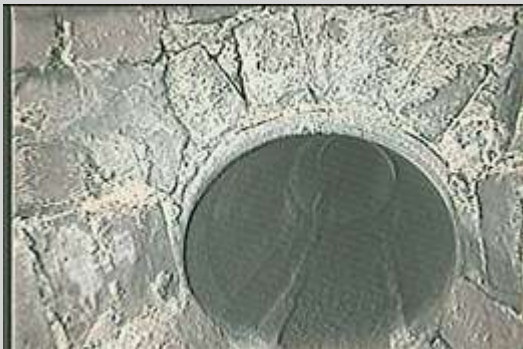
10 in. Circular Gravity Sewer Pipe In @ 8 O'Clock

Deposits: ☐ None ☐ Mud ☐ Sludge ☐ Debris ☒ **Grease**

Infiltration: **Evidence** Pipe Seal Cond: **Cracked**
